# Captina Creek Watershed Natural Gas Pipeline Crossings

Captina Conservancy  
Barnesville, Ohio  
August 2021

This report is an informational document on the current state of natural gas pipeline creek crossings in the Captina Creek Watershed in Belmont County, Ohio.

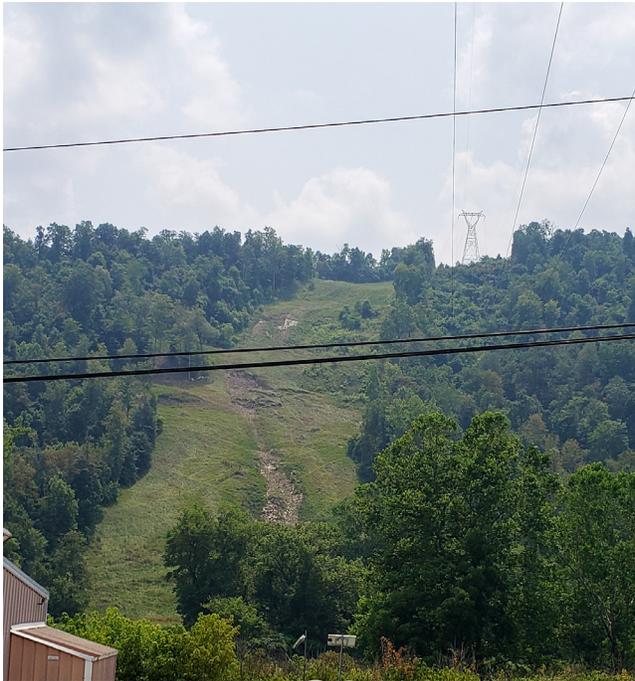
### **1 = Bad:**

- Land is unstable with minimal to no vegetation; some slippage, bare soil, and/or erosion
- Negative impact on water quality likely during storm events from fast, sedimented runoff

**Figure 6:** Bad [1] Example (CC\_EQT\_2)

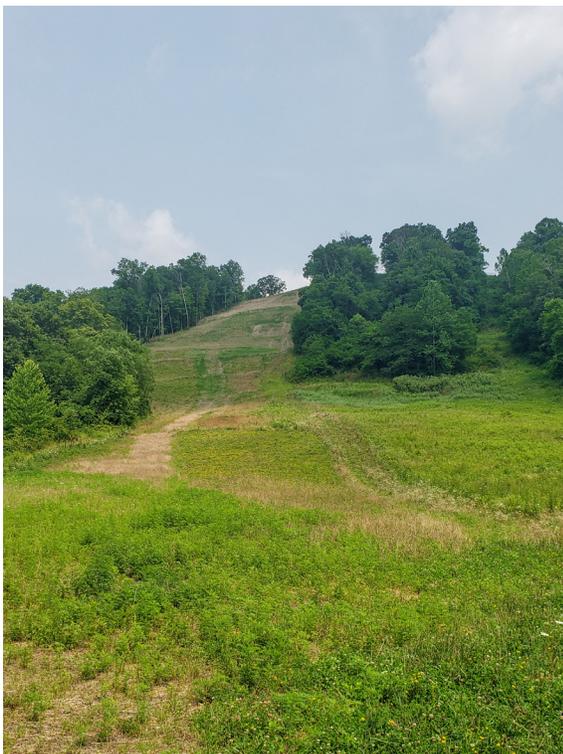
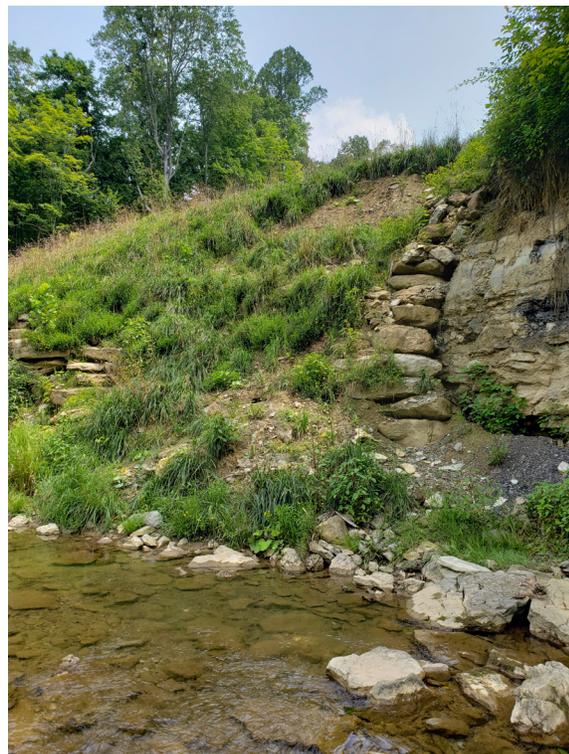
**Figure 7:** Bad/Okay [1.5] Examples (CR\_R and CR\_D; PV\_R)

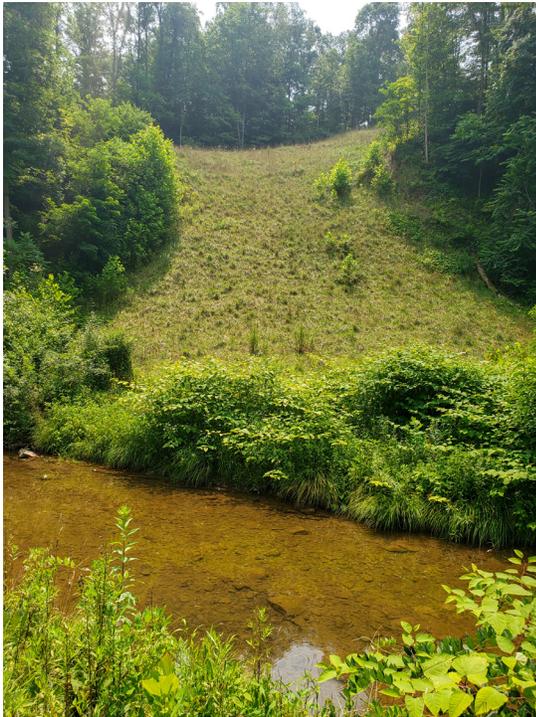
### **2 = Okay:**

- Land is stable and minimally vegetated in ways that will not sufficiently slow water runoff
- Some negative impact to water quality likely during storm events from fast runoff

**Figure 8:** Okay [2] Example (CR\_EQT\_2)

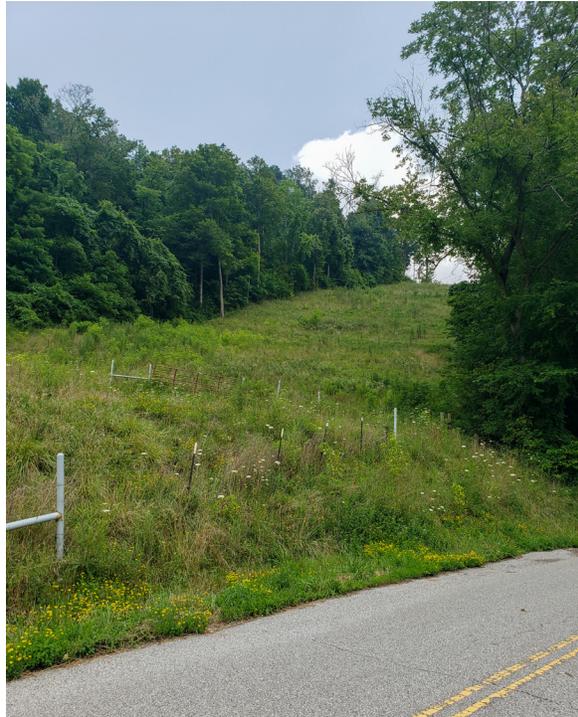
**Figure 9:** Okay/Good [2.5] Example (CR\_ET)

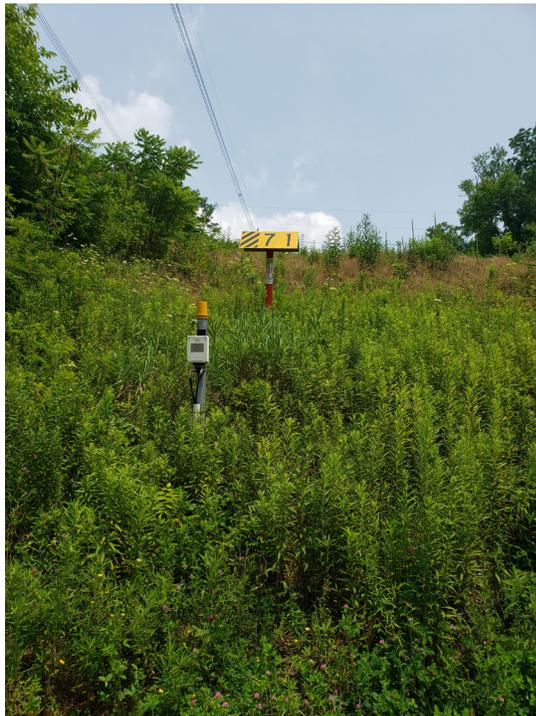
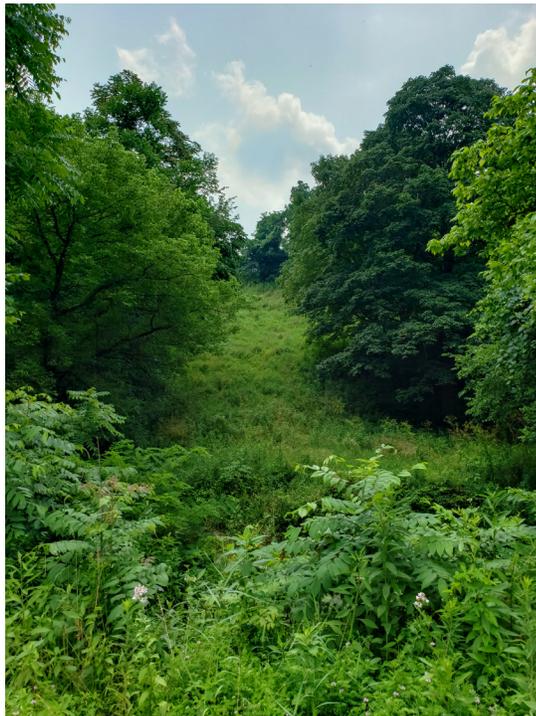
### **3 = Good:**

- Land is stable, but could be steep, and well vegetated in ways that will slow water runoff
- Little to no impact on water quality likely during storm events

**Figure 10:** Good [3] Examples (CR\_TET; PV\_BRM)

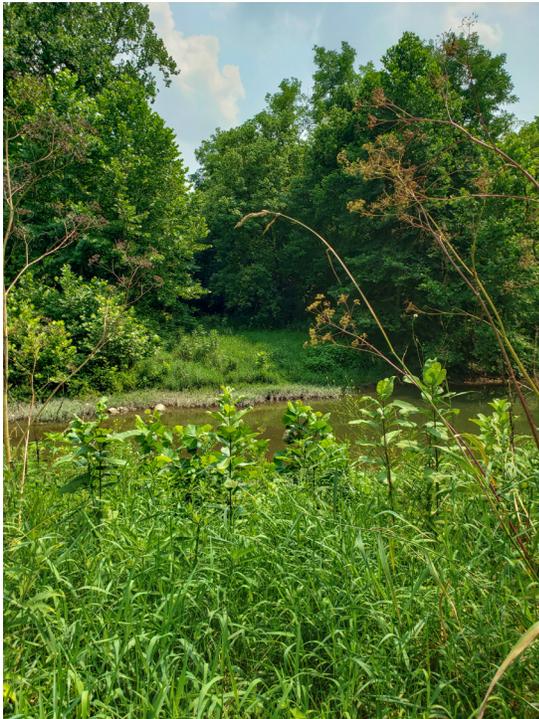
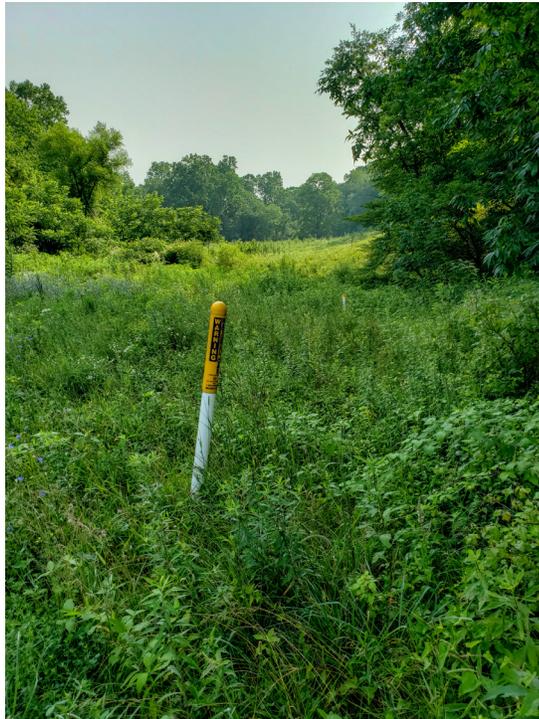
**Figure 11:** Good/Best [3.5] Examples (CC\_D\_1; SF\_OG\_3)

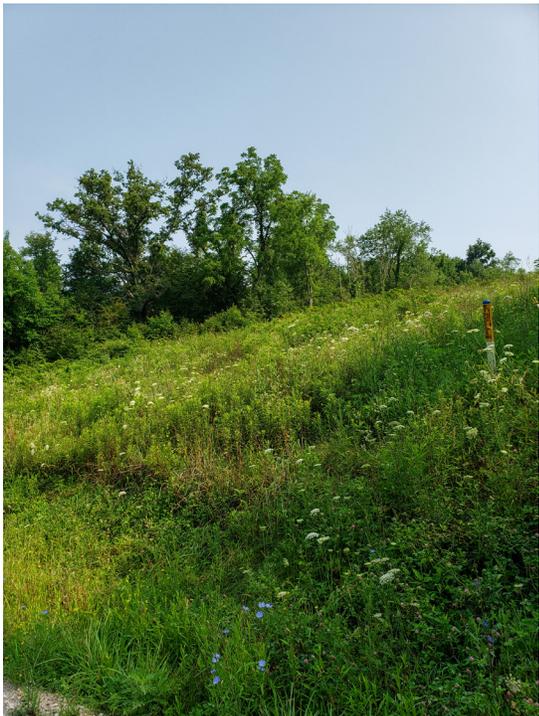
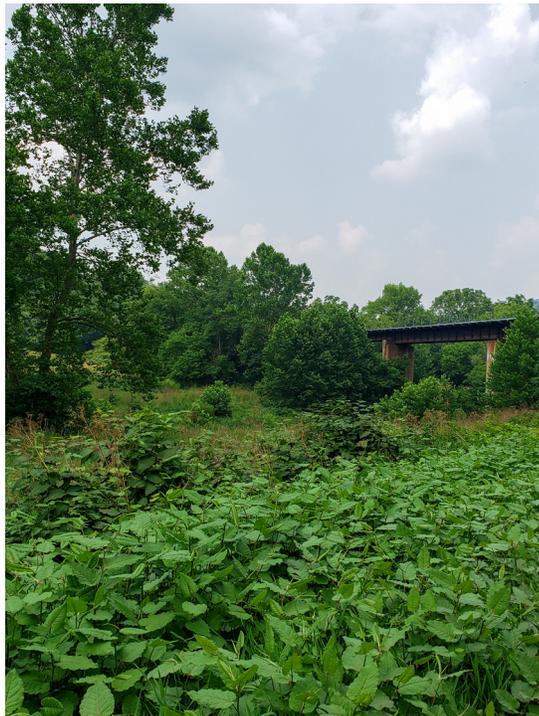
### **4 = Best:**

- Land is stable, not too steep, and well vegetated
- Vegetation creates habitat for pollinators and other land animals
- No impact to water quality likely during storm events
- Additional riparian habitat benefits

**Figure 12:** Best [4] Examples (SF\_OG\_2; CC\_BRM\_3)
